**An Assessment of the Emergency Egress Characteristics  
of the U.S. Army Airborne Command and  
Control System (A2C2S)**

**ARL-MR-0635**

**January 2006**

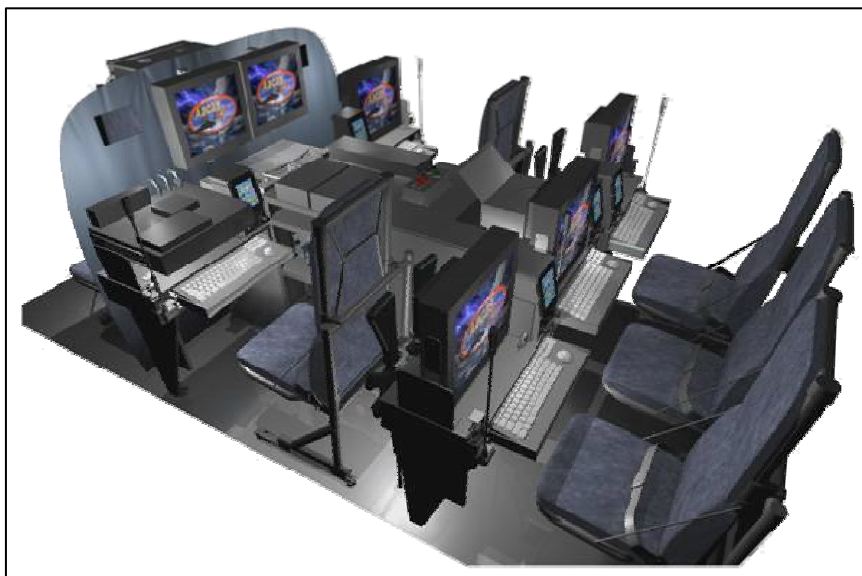
The Army Airborne Command and Control System (A2C2S) (see figure 1) is a command and control (C2) system consisting of an A-kit and a B-kit and will be hosted by the utility helicopter (UH)-60L (and newer) Blackhawk. The A-kit is permanently affixed to the airframe and consists of antennas, wiring, and aircraft interfaces (e.g., power, structural, etc.) that enable the B-kit to be installed in the airframe.

Figure 1. A2C2S.

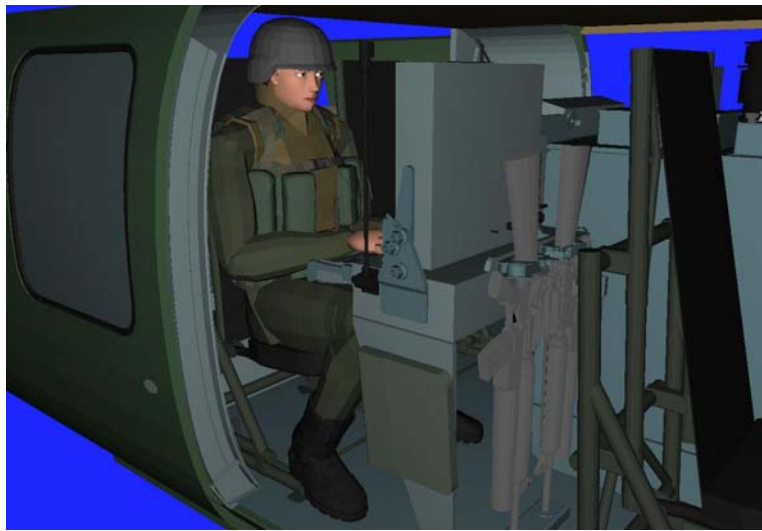
The first egress task examined simulated the operator seated at the right rear workstation position (figure 5) and exiting through the left side cargo door. This scenario assumes an inoperable right side cargo door or a blocked right side cargo door opening.

Figure 5. Human figure model seated at the right rear workstation.

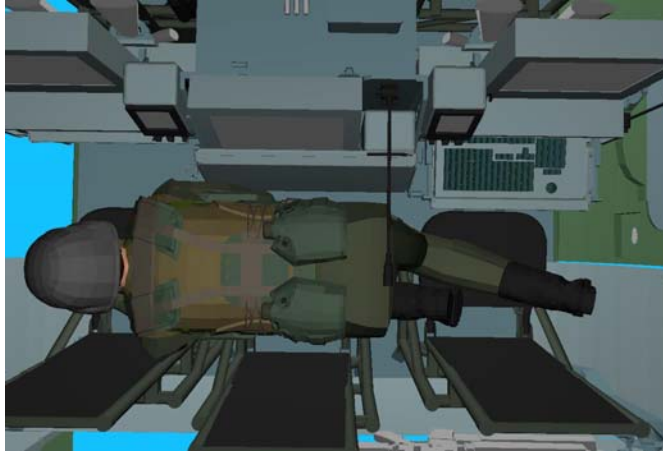
There are two egress strategies that the workstation operator would probably employ for this scenario. The first would involve the operator using the seat pans of the two adjacent seats as crawling surfaces and traversing the aircraft from right to left in this manner. The rear seat pan to ceiling dimension is 37.0 inches and the seatback to workstation distance (with the center workstation keyboard folded back into the stowed position) is 24.25 inches. This crawl space area of 37.0 by 24.25 inches would provide sufficient space for a large male to crawl across the seats and exit through the left side cargo door (see figure 6).

Figure 6. Human figure model leaving over rear seats.

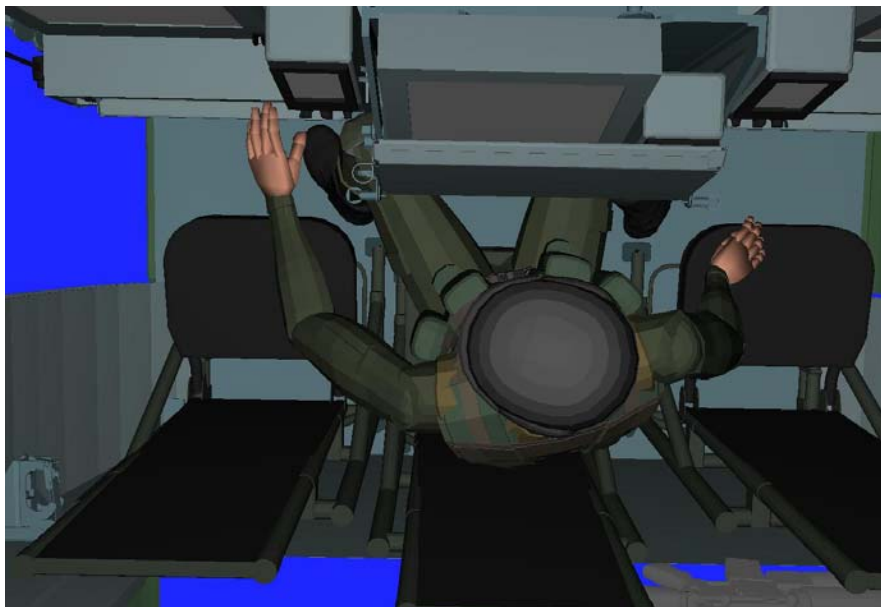
The other egress strategy would have the operator maintain a seated posture and slide the hips across the other two adjacent seats (see figure 7).

Figure 7. Human figure model sliding across rear seats.

Figure 7 also shows that the operator has retracted the right and left keyboards and folded the center workstation keyboard into a stowed position in order to maximize the available space during this type of egress. With these keyboards moved out of the way, sufficient space does exist for the operator to perform the egress in this manner. One possible problem area noted when this type of egress is performed is shown in figure 8. Large males could have a problem with their heads striking the upper left-hand corner of the flat screen monitor just before they exit the aircraft through the left cargo door opening.

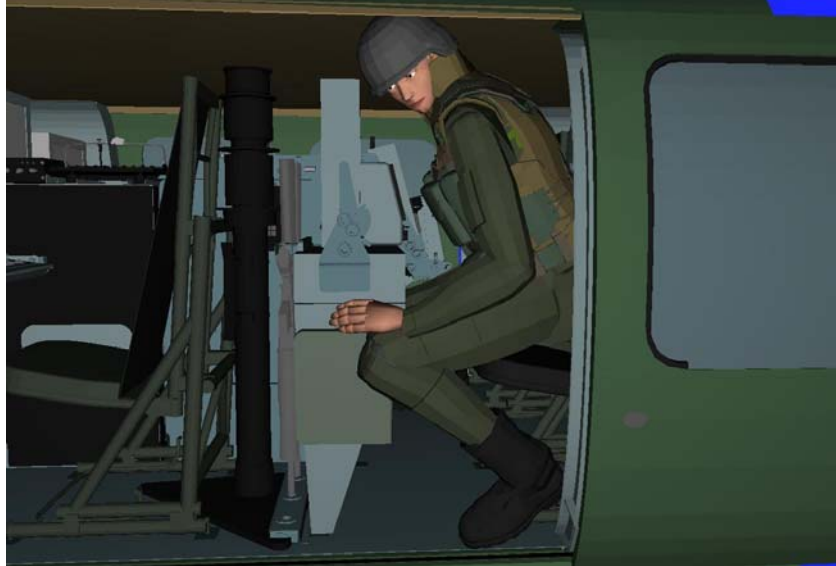
Figure 8. Human figure model sliding across rear seats.

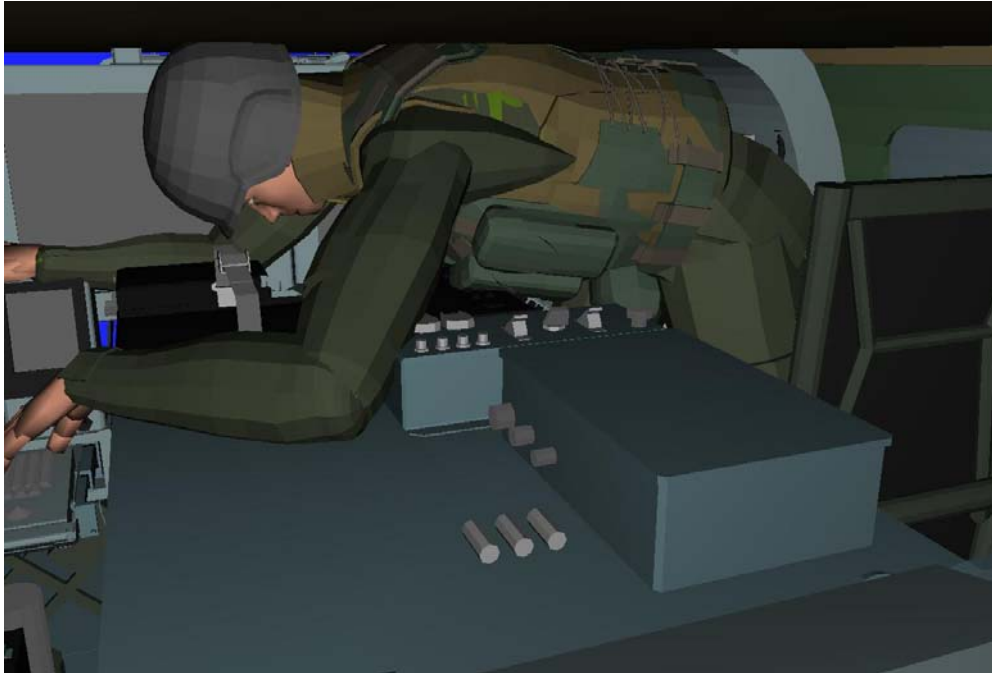
The dimensions taken from the CAD model show that the clearance between the top of the center console and the interior aircraft ceiling narrows to as little as 10.75 inches. Therefore, the two most critical body dimensions that must be examined are the chest depth and buttock depth. The large male figure used in this analysis has a chest depth dimension of 11.26 inches and a buttock depth of 11.40 inches. However, these are standing dimensions and when a person assumes a crawling position, one could expect significant soft tissue compression along with a compression of the chest cavity so that even a large male Soldier should be able to squeeze through the limited space available over the center console if the standard BDU clothing worn did not include any additional equipment. On the other hand, an LBV such as the one worn by the large male human figure in this analysis, can add 4 to 5 inches to the chest depth measurement and would make egress over the center console very difficult, if not impossible, for the larger end of the male Soldier population (see figure 11).

Figure 11. Large male figure attempting egress over the center console.

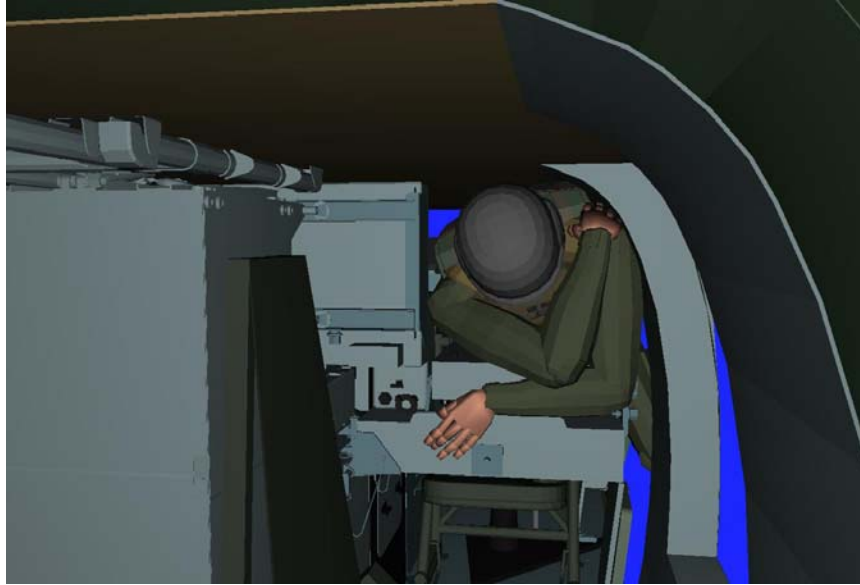
The body dimensions of most concern for this egress route are the shoulder width (bideltoid breadth), chest depth, and buttock depth. The bideltoid breadth for the large male figure used for this evaluation is 21.25 inches and the chest depth and buttock, which were mentioned earlier, are 11.26 inches and 11.40 inches, respectively. This bideltoid breadth dimension slightly exceeds the available space dimensions if the operator were to perform the egress with his chest lying on top of the monitor. However, if instead, a strategy is employed whereby the torso is rotated to the left or right by about 45 degrees, the operator would then have enough room to clear the shoulders through the opening and successfully perform the egress (see figure 14).

Figure 14. Large male figure positioning shoulders to leave over workstation.

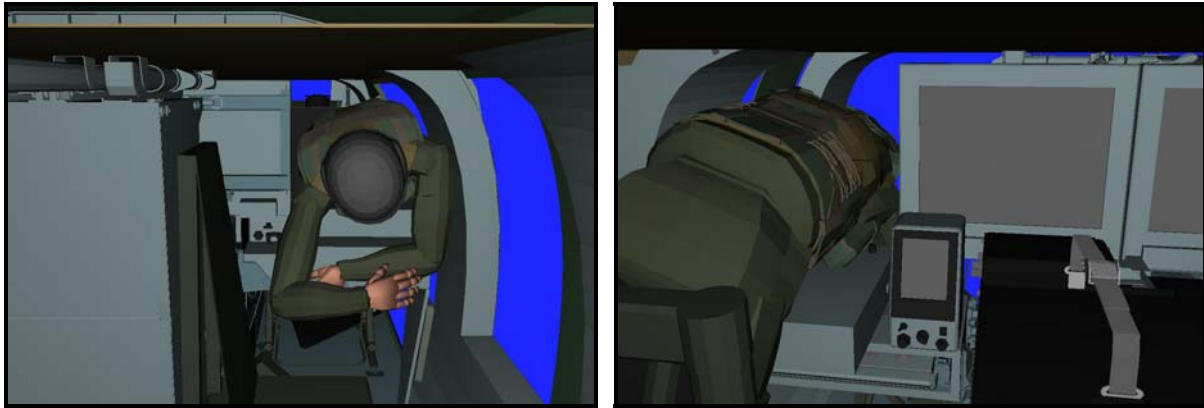
Once the shoulders have cleared, sufficient room exists, even for the large male wearing the added clothing and equipment items, to clear the rest of the body through the opening (see figure 15).

Figure 15. Aft and forward facing views of large male figure clearing shoulders through workstation.

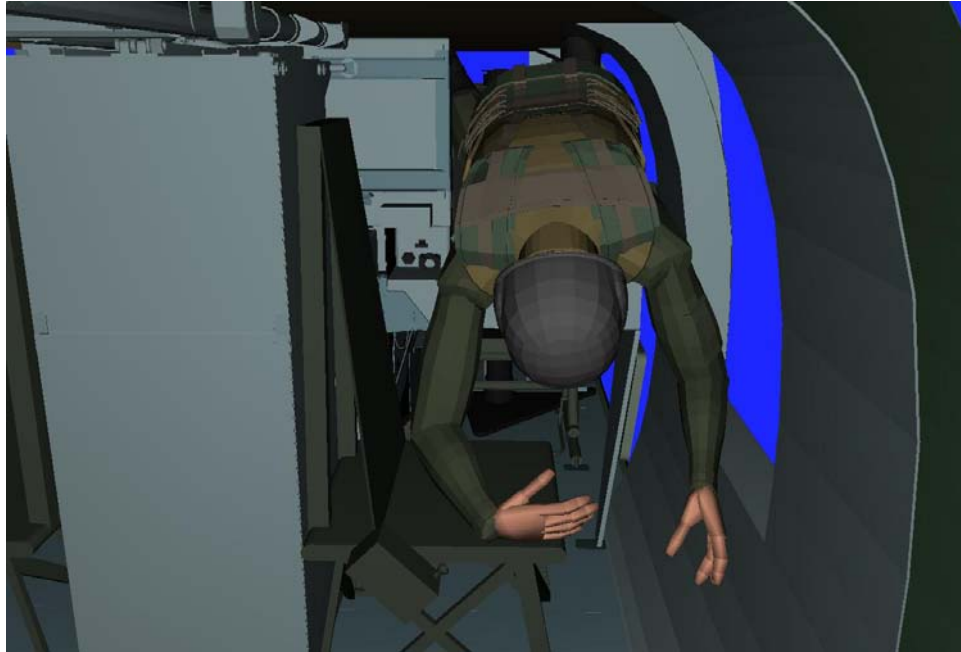
One other point to note about this egress route is that once the operator is able to clear the torso through the opening, the seat on the other side of the workstation can be used for support, in addition to providing a structure that can be used to pull the rest of the body through the opening (see figure 16).

Figure 16. Large male figure using the crew chief for support.

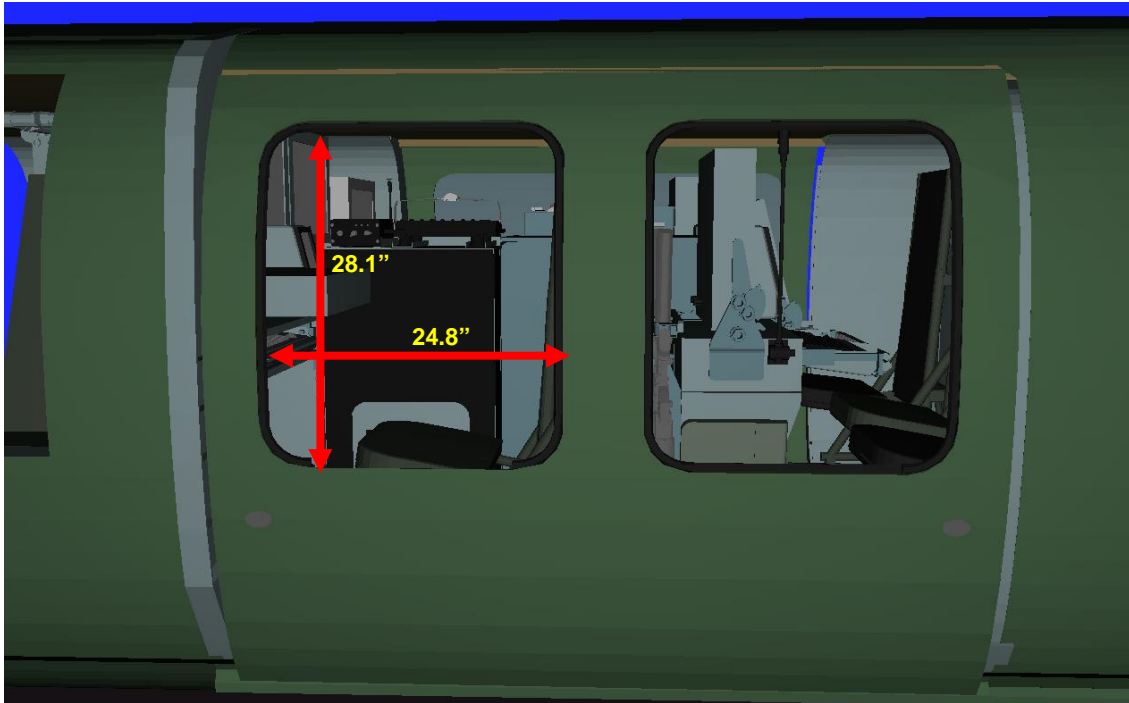
Figure 19. Dimensions of side cargo door window openings.

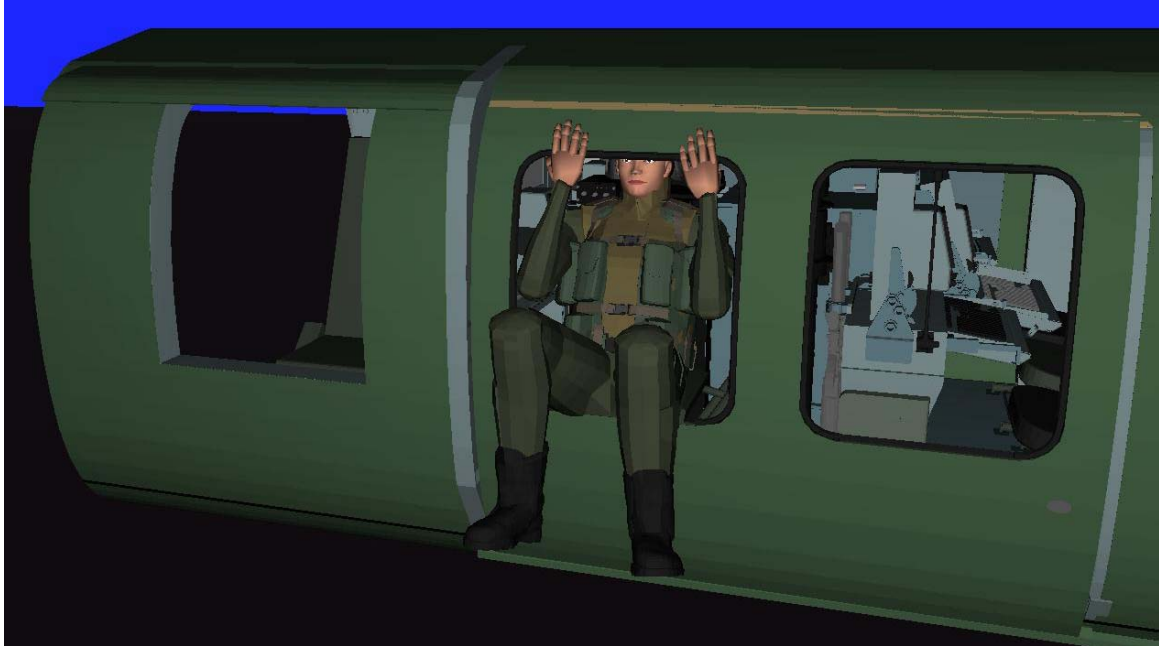
Figure 21. Exterior view of the large male figure leaving through left front cargo door window.

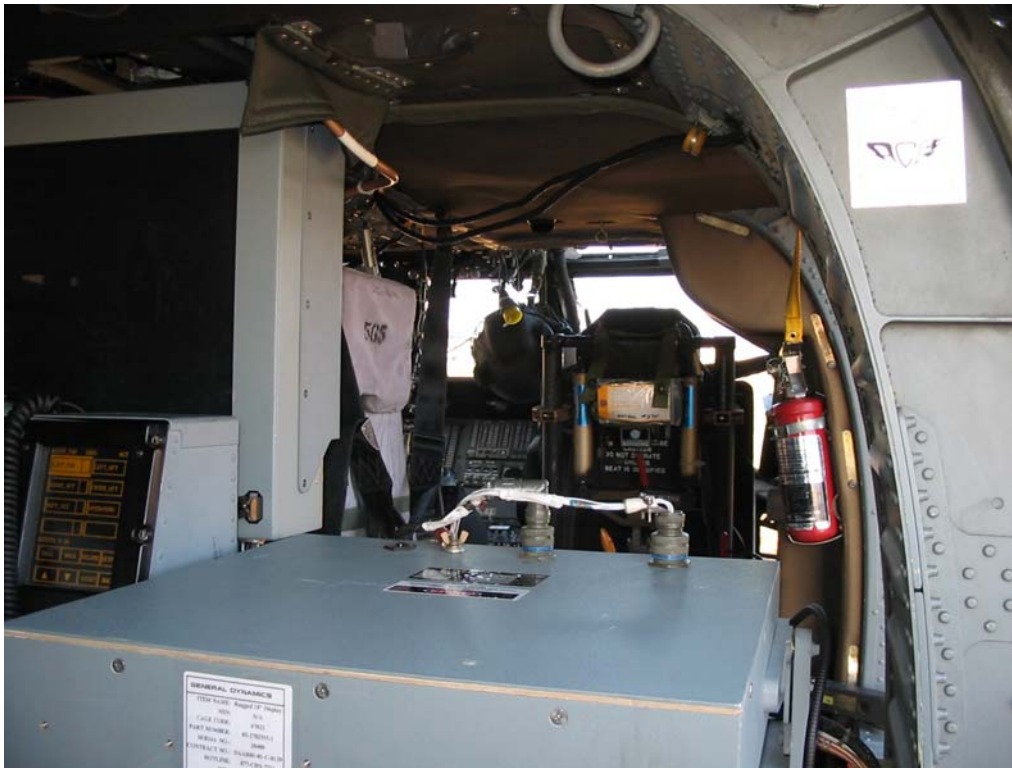
The second phase of egress trials included blocking the exits on the left side of the aircraft to simulate an aircraft on its side or otherwise blocked exits. During these trials, the three rear operators maneuvered across the back row of workstations and exited through the right cargo door. The front right operator also exited through the right cargo door. The operator seated at the left front workstation was the large male participant. This operator exited the aircraft by lowering the workstation monitor, crawling over the workstation into the crew chief station, and exiting through the right gunner's window. Figure 22 shows the opening over the workstation provided when the monitor is folded down. The operator was unable to egress over the center console because of the restricted space between the center rack and the cabin roof. Figure 23 shows the space restriction caused by the height of the center rack. The recorded times for these three trials ranged from 17 to 23 seconds, and the average egress time was 19.3 seconds.

Figure 22. Egress route over workstation.

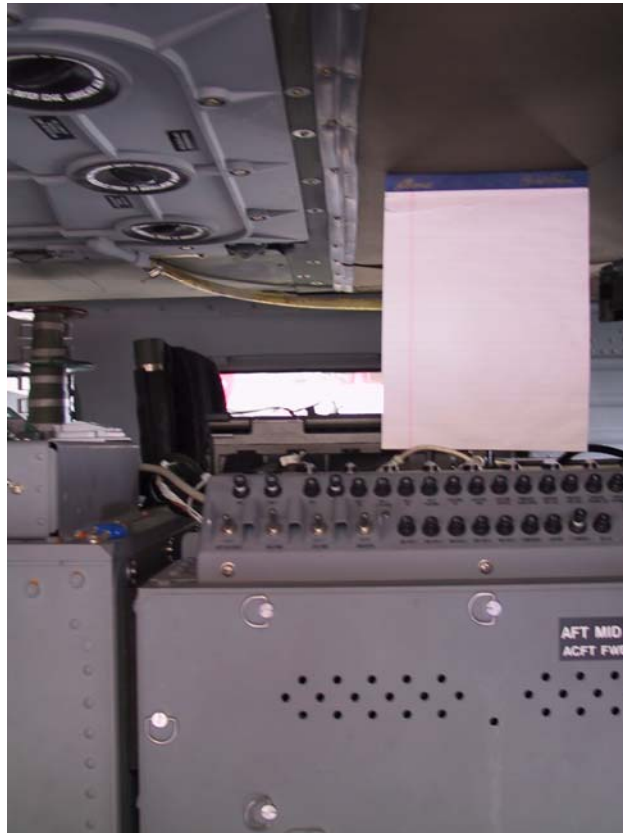
Figure 23. Restricted space above center rack.

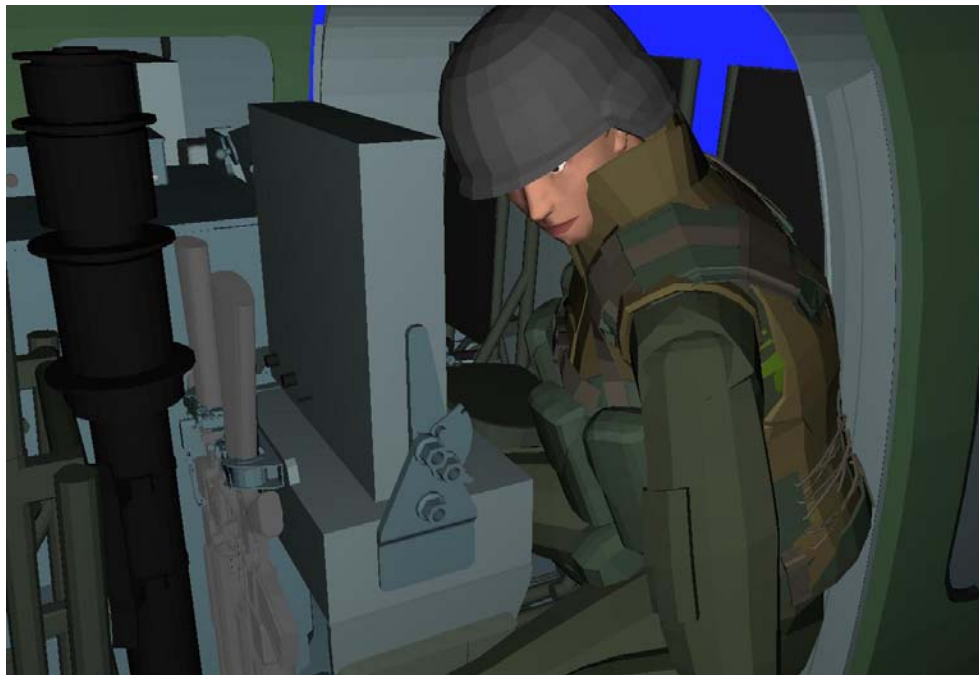
The first recommendation pertains to egress from the rear workstation positions or, more specifically, the first type of egress analysis addressed in the results section. As noted in the results section, larger Soldiers could have problems with head contact to the upper outboard section of the flat screen monitor at the right or left rear workstation positions. A solution that would provide extra headroom would be to allow the flat screen monitors to rotate back beyond the full upright position. The current rotation back seems to be limited to about 20 degrees because of weapon stowage in back of the right and left rear workstation positions. However, even this limited rotation of the monitors could provide the additional space to make egress from the rear workstation positions easier for the larger Soldiers (see figures 24 and 25).

Figure 24. Restricted head space with monitor positioned upright.

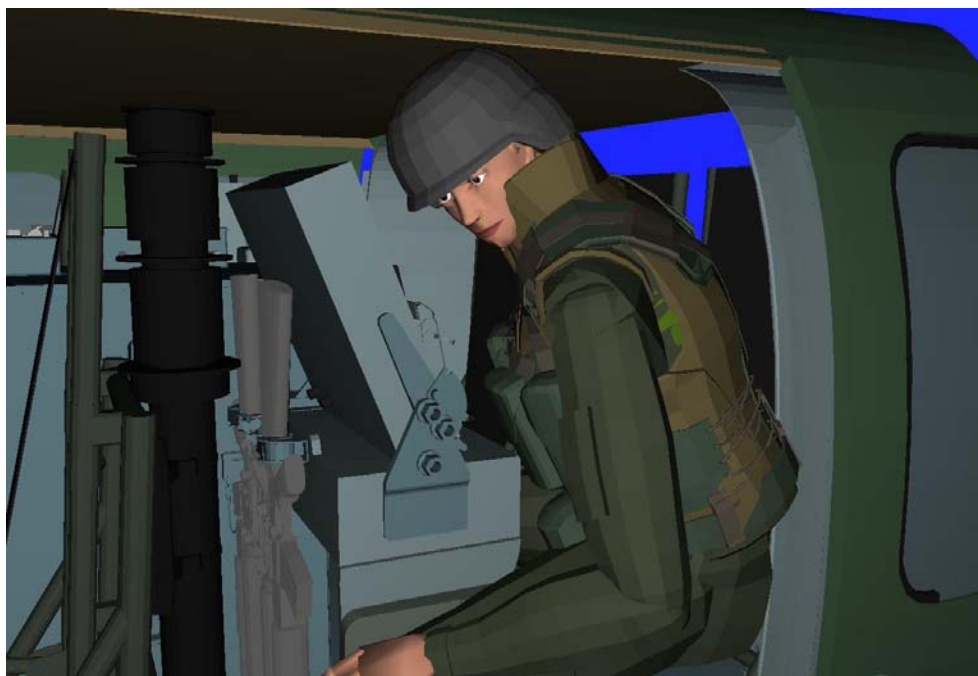
Figure 25. Additional head space provided by rotating monitor backward 20 degrees.

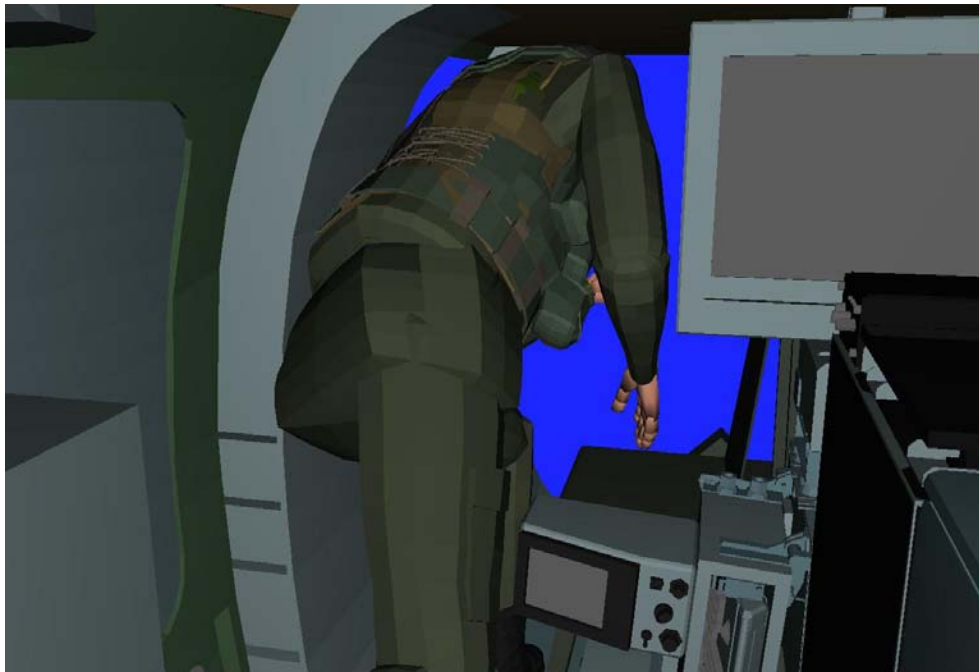
Figure 27 shows the clear benefit provided by the additional space created when the workstation platform collapses. This potential design alternative would provide ample space for even large male Soldiers to use for an egress path and would be much more preferable than their having to climb over or crawl underneath the workstation.

Figure 27. Large male figure leaving through space provided when workstation is folded down.
